FEASIBILITY STUDY FOR MALDEN CENTER FOR ARTS & CULTURE AT 89 SUMMER STREET, MALDEN, MA 02148

MALDEN CENTER FOR ARTS &
CULTURE

89 SUMMER STREET,
MALDEN, MA 02148

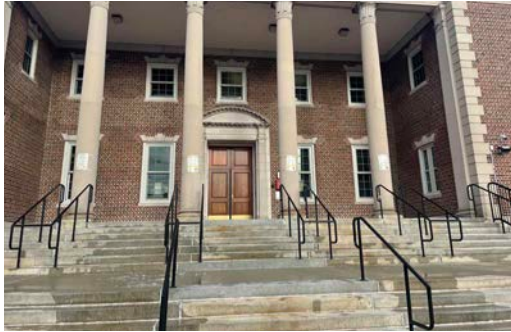
Exterior - Photo 1

The building at 89 Summer Street has been well maintained through the years. The exterior envelope seems to have been restored within the last 10 years. The exterior brickwork is in good condition and appears to have been repointed, the windows are in excellent condition, and the roof appears to have been replaced and has a number of years left of service.

Other exterior envelope work includes cleaning of the brick, stone, and concrete, selective repointing and masonry repair, and general maintenance. Existing egress stairs from the lower level and first floor to remain all have non-code compliant handrails and guardrails and will need to be replaced as a part of this project.

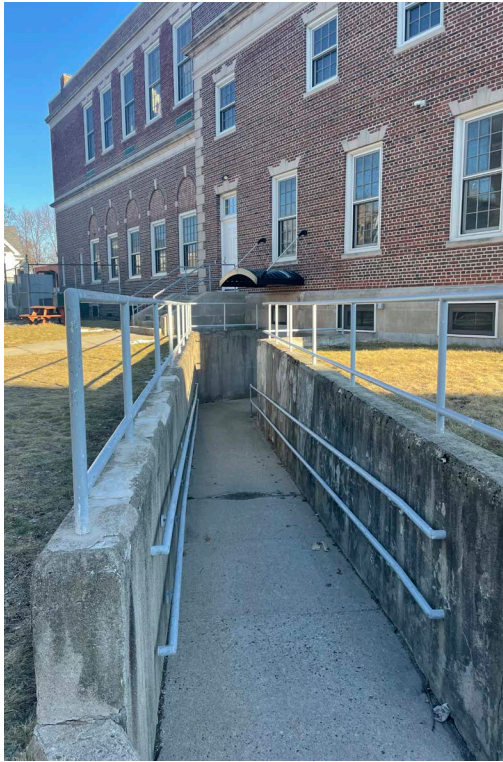
Existing ramp to be modified for new main entry ramp

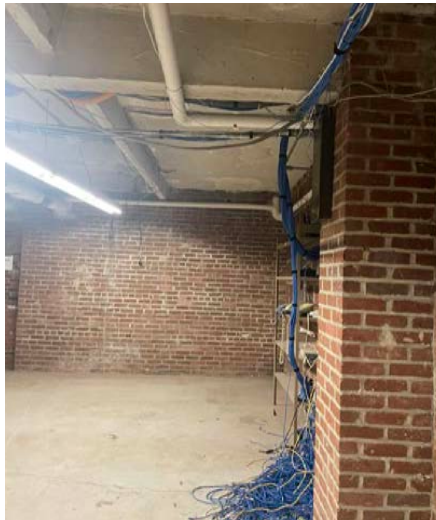
Minimal lighting in lower level

Typical existing condition of lower level

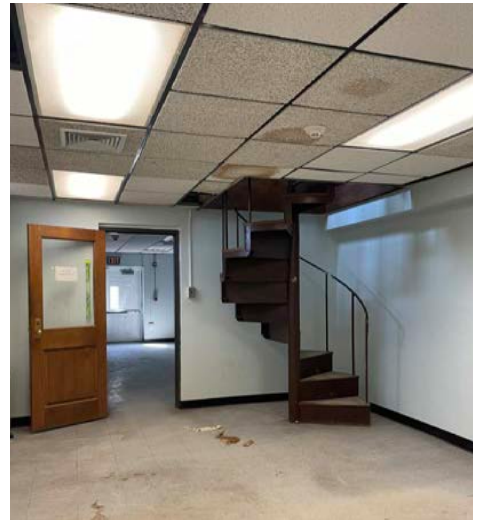
Typical existing condition of lower level

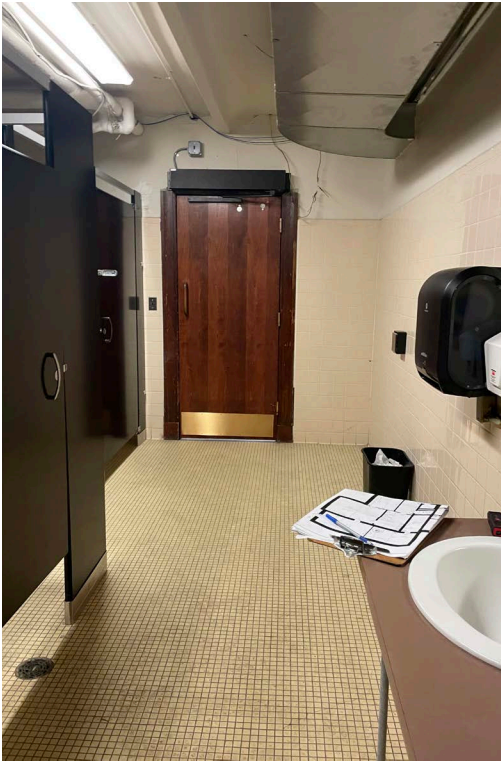
Typical existing restrooms

Existing restrooms are dispersed throughout the building due to the nature of a courthouse needing to separate the various parties attending trials. As a result, plumbing is spread out across the building however there are not centrally consolidated restrooms in quantities or locations that are ideal for the new arts and culture center. Note that on the lower level, there are existing jail cell fixtures with stainless steel benching. (Photo 2)

There is a great deal of interest in non-gender restrooms and this project proposes to utilize these at all levels. All existing restrooms will be demolished. New restrooms will have toilets separated by walls and doors, tile floors, wall tile to 4', paint, modern lighting, ACT ceiling finishes, and new sinks in shared solid surface countertops. See diagram and precedent images as reference.

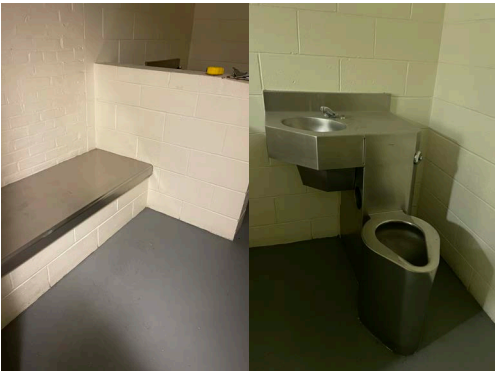
Typical holding cell restrooms

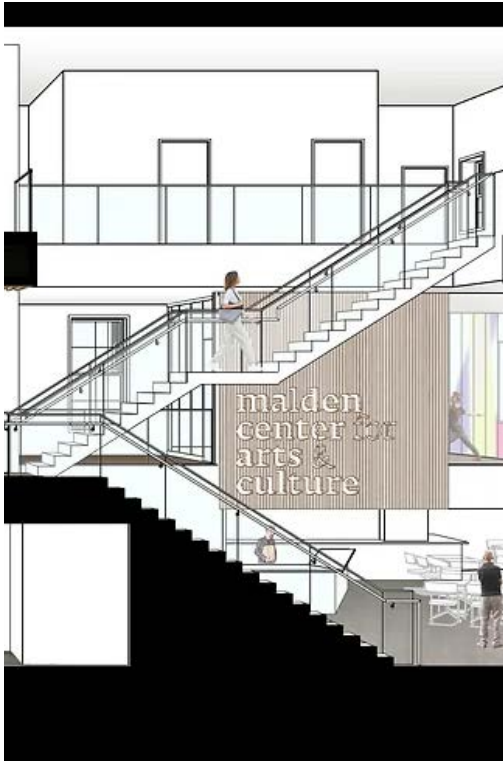
Existing stair to be removed

The new feature stair from the entry lobby to the first floor will be a “museum quality” stair with glass railings and stone or wood block treads. The existing stair will need to be removed to create space for this new feature element.

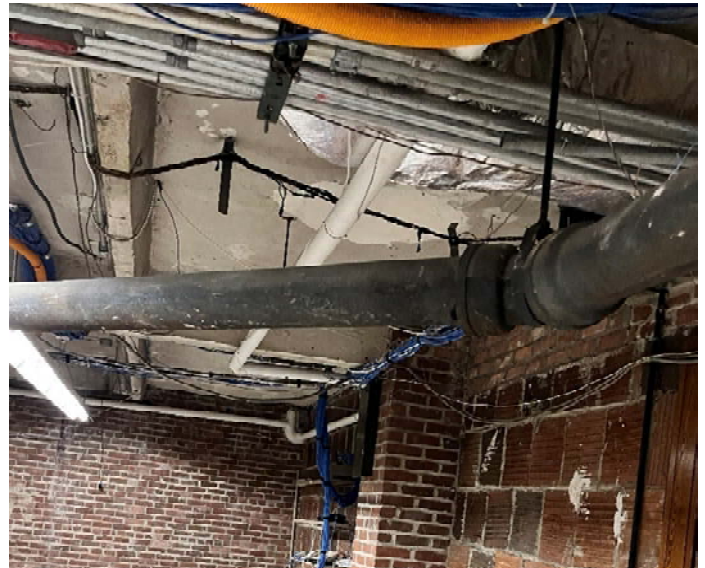
Photo 8

The existing building foundation walls were partially visible at the unfinished basement level. It is assumed that the existing building is supported on these foundation walls that continue below grade and bear on a wall footing. The upper portion of the walls is masonry at the interior and stone at the exterior. The lower portion of the walls is concrete at the interior and could not be observed at the exterior (Photos 4 &5). The overall condition of the foundation was good with only two cracks noted. These cracks occurred below a beam that was supported at the top of the wall. It is common to see cracks in these locations. The cracks were not structurally concerning due to their modest size (less than ¼") but should be monitored for any changes (Photos 6&7). There were no other signs of deflection or distress. It is assumed that the basement level slab is a slab on grade and the interior masonry piers bear on spread footings below (Photos 8, 14 &15).
