FEASIBILITY STUDY FOR MALDEN CENTER FOR ARTS & CULTURE AT 89 SUMMER STREET, MALDEN, MA 02148

MALDEN CENTER FOR ARTS &
CULTURE

89 SUMMER STREET,
MALDEN, MA 02148

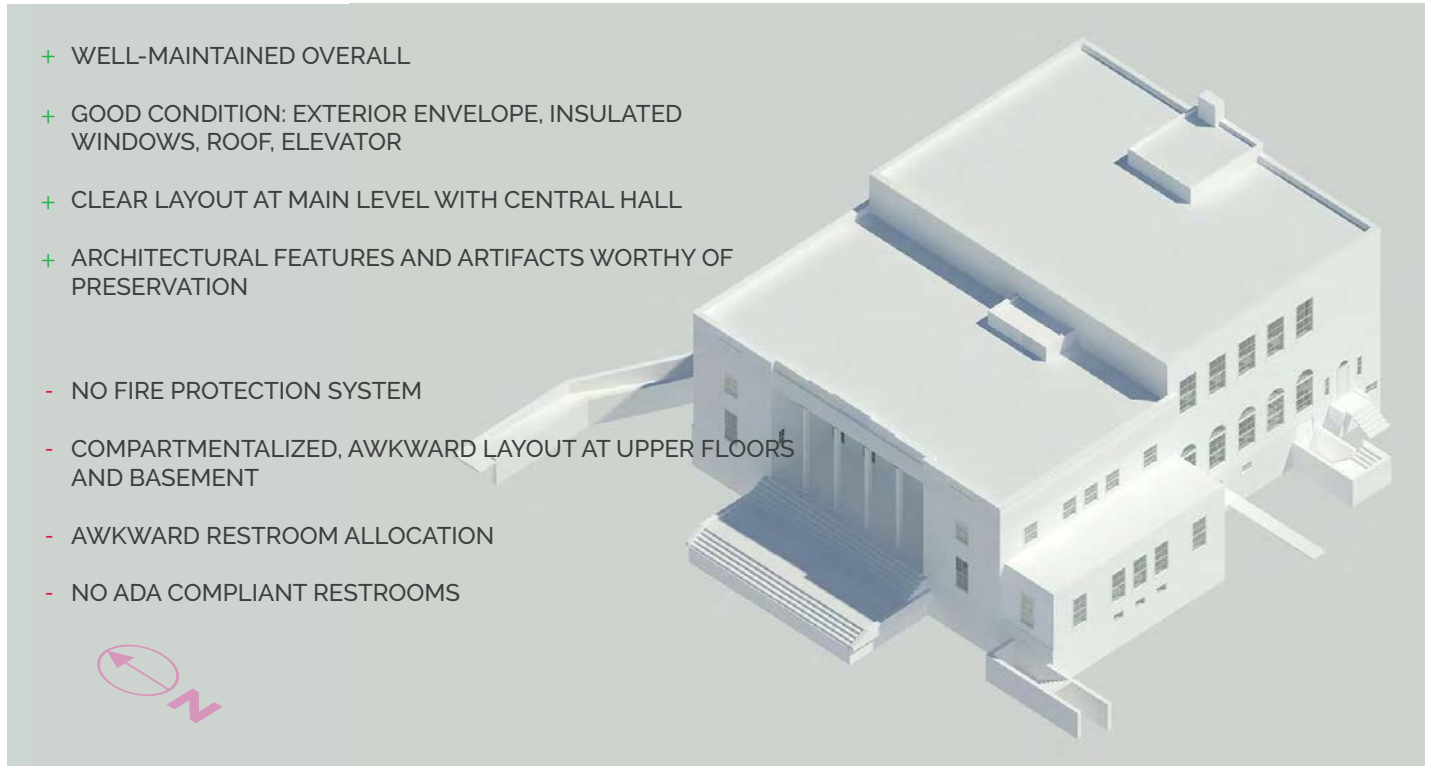
The building at 89 Summer Street has been well maintained through the years. The exterior envelope seems to have been restored within the last 10 years. The exterior brickwork is in good condition and appears to have been repointed, the windows are in excellent condition, and the roof appears to have been replaced and has a number of years left of service.

Other exterior envelope work includes cleaning of the brick, stone, and concrete, selective repointing and masonry repair, and general maintenance. Existing egress stairs from the lower level and first floor to remain all have non-code compliant handrails and guardrails and will need to be replaced as a part of this project.

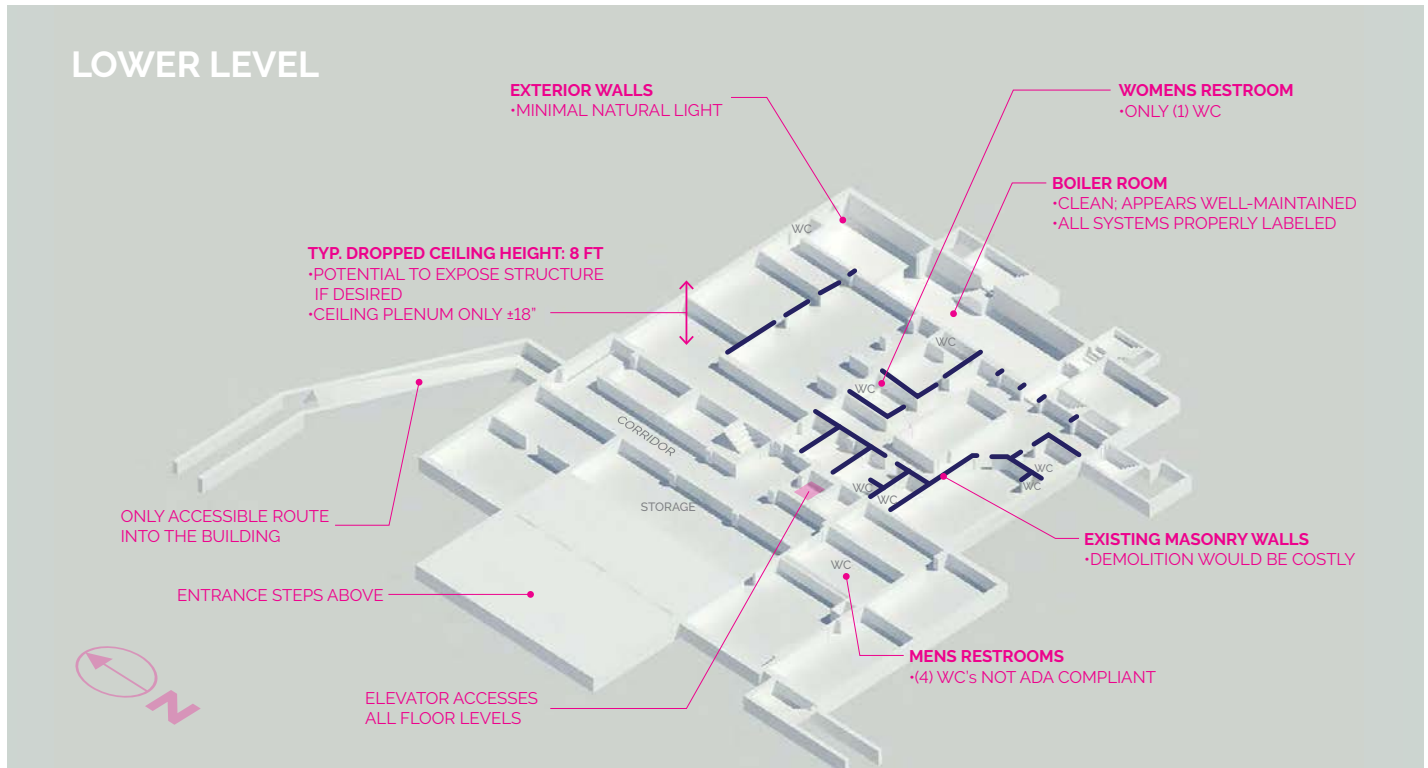
The lower level floor of the building contains the only accessible existing route into the building however it is not at all welcoming today. This floor has much of the HVAC and electrical equipment located on this level. There is no sprinkler in the building so space will need to be allocated in the lower level for a new water service and sprinkler system. Refer to the IMEG section later in the document that outlines requirements for the sprinkler system.

The lower level is where people awaiting their trials were held in jail cells that are constructed of concrete block walls and steel doors. All of the cells have stainless steel plumbing fixtures. The typical dropped ceiling height is 8ft with an 18" plenum space, with the potential to expose the structure for a larger ceiling height if desired. The exterior walls emit a minimal amount of natural light and there are existing masonry walls that contain compact jail cells within the building. The existing restrooms do not meet current building codes and need to be replaced throughout.

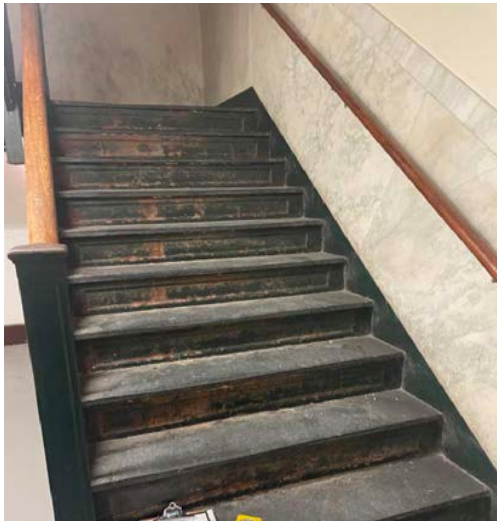
Existing stair to be removed for new stair in double height opening

The new building lobby and entrance will welcome visitors into a new well lit double height active space via the new accessible entry and ramp (Photo 1). The space will feature new storefront windows, a feature stair to the first floor, and open cafe space. The design includes a digital display to help visitors find the exhibition, performance, recording studio, art space, or classroom they are looking for.

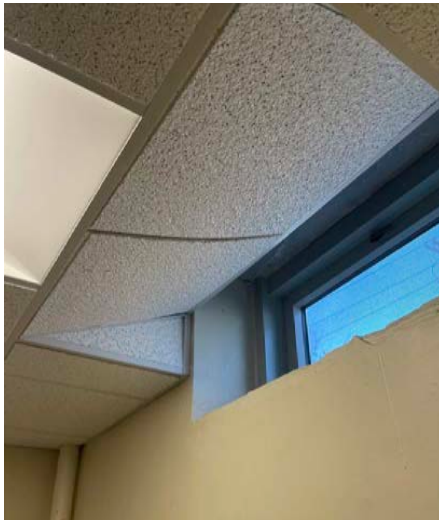
Minimal lighting in lower level

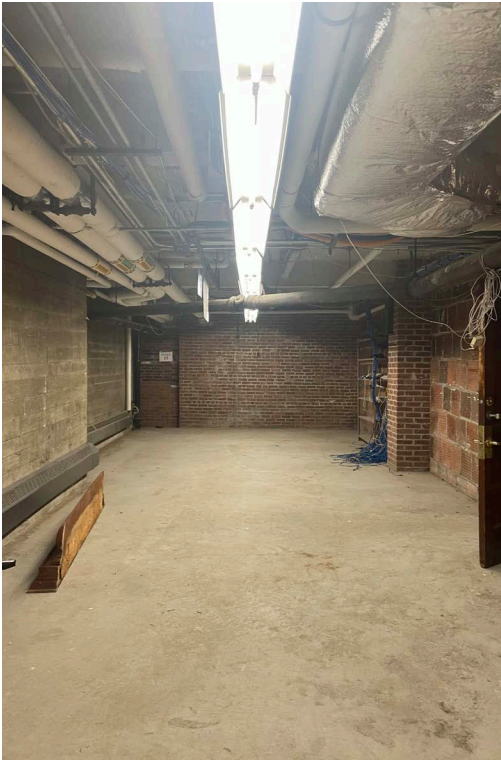
Typical lower level condition

Storage and ancillary spaces to be added with updated finishes - new walls, paint, VCT and proper lighting. Large utility room to remain generally untouched. Updated and new building systems for the entire building will be contained at this level per the IMEG report contained within this report. (Photo 2)

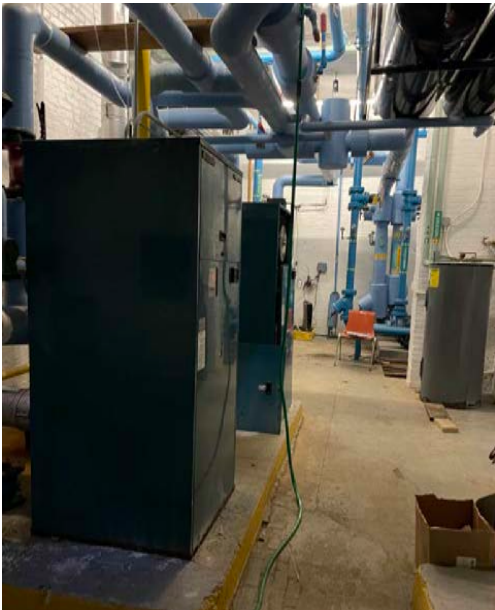
Existing mechanical room

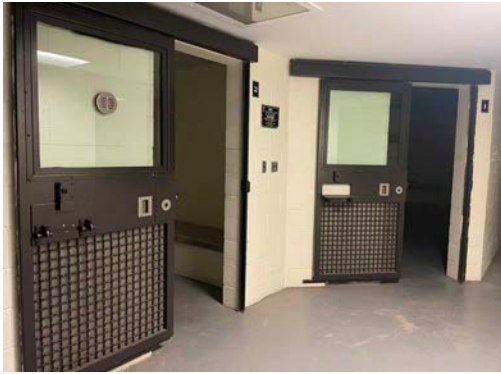
Existing holding cells where future music studios will go

Recording Studios and Music Practice Room: these are to be “box in box” construction so that they are acoustically isolated from the structure. Sound absorbing materials are to be provided inside the rooms.

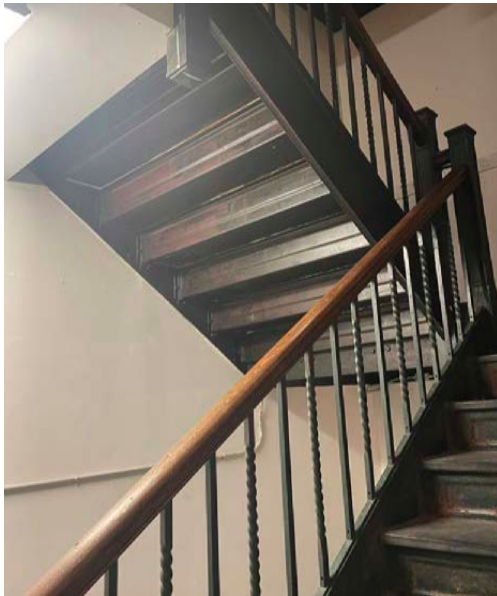
Existing stair to be removed

The new feature stair from the entry lobby to the first floor will be a “museum quality” stair with glass railings and stone or wood block treads. The existing stair will need to be removed to create space for this new feature element.

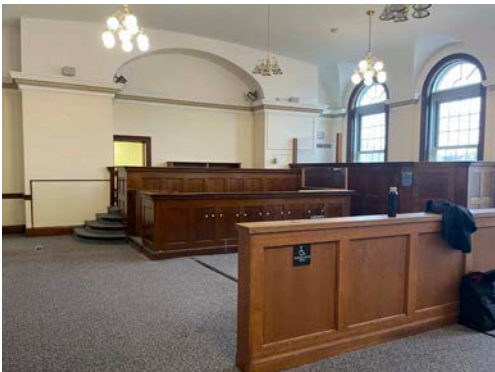
Existing courtroom, note high ceilings ideal for art, dance or performance

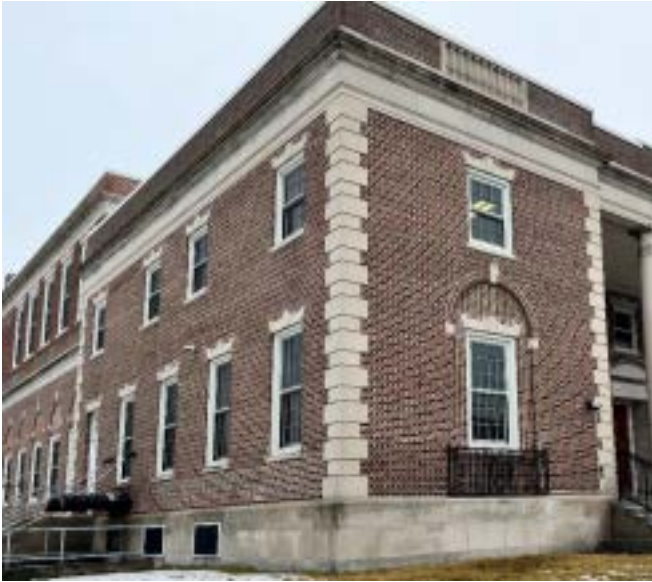
Photo 1

The exterior of the building was in good structural condition. There were no signs of settlement or deflection to the masonry walls or foundation walls that were visible above grade (Photos 1-3). There were no large cracks in the stone blocks at the foundation or the exterior face of the masonry walls above.

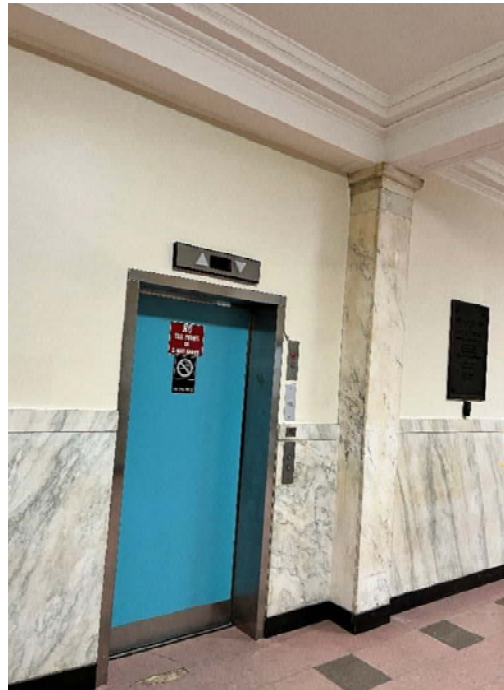
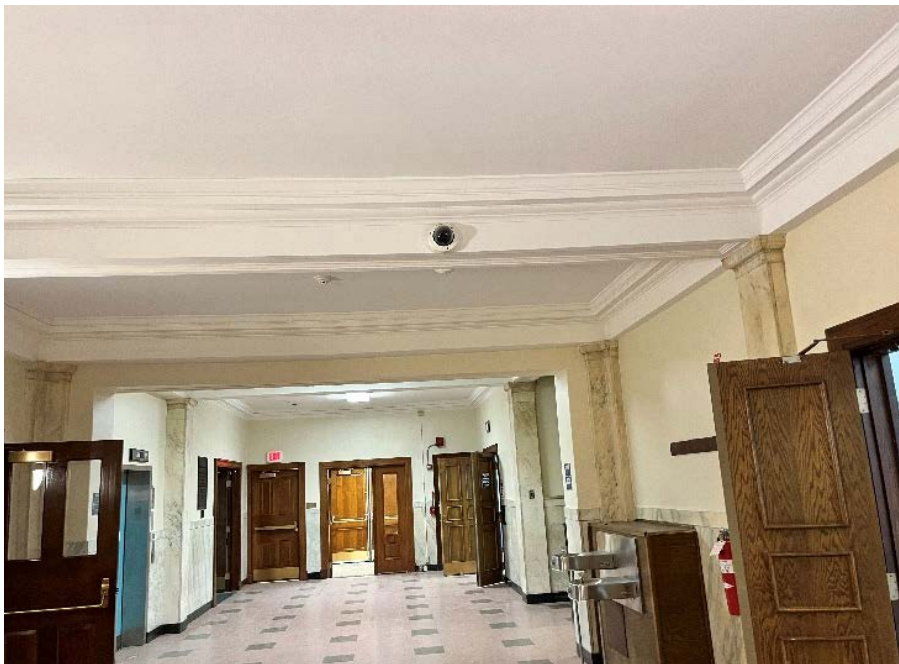
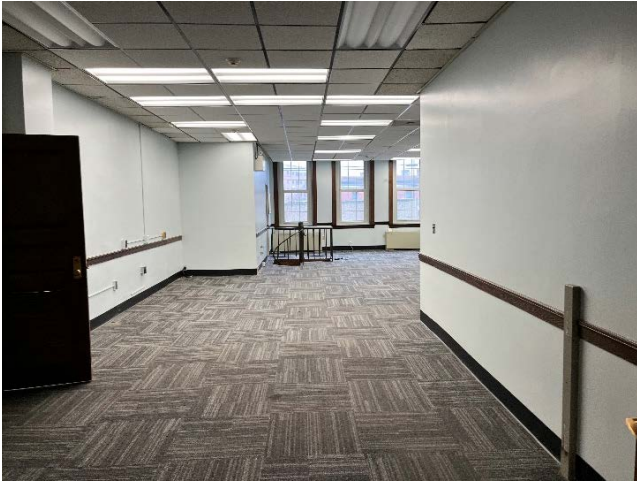
The second-floor framing was also covered with finishes, but at the main corridor there were soffits which are assumed to cover beams and columns (Photos 16-18). At the front rooms off the main corridor there was a dropped ceiling and above that a plastered ceiling which covered the framing (Photo 19-20). Based on the framing at the first floor and the 1972 elevator drawings it is assumed that the framing at the front rooms is 2"x13½" wood joists spanning to masonry bearing walls or steel beams that are supported on steel columns. The second-floor framing at one of the rear rooms off the main corridor could be observed through an access hatch and was found to be 2x10 joists supported on an angle member that was bolted to a W21 steel beam (Photos 21-25). The wood joists have been notched to fit into the space under the top flange, at one location a split in the joist was noted (Photo 25). It is assumed that there is a similar floor assembly at the other rear room across the corridor from this one (Photo 26). There were no signs of significant deflection or distress of the second-floor framing members or the finishes.

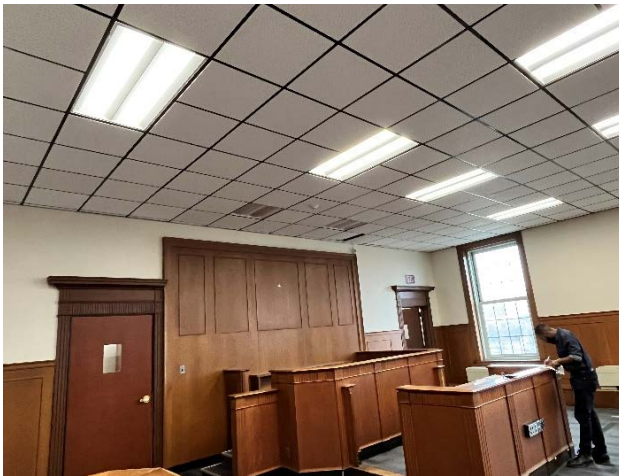
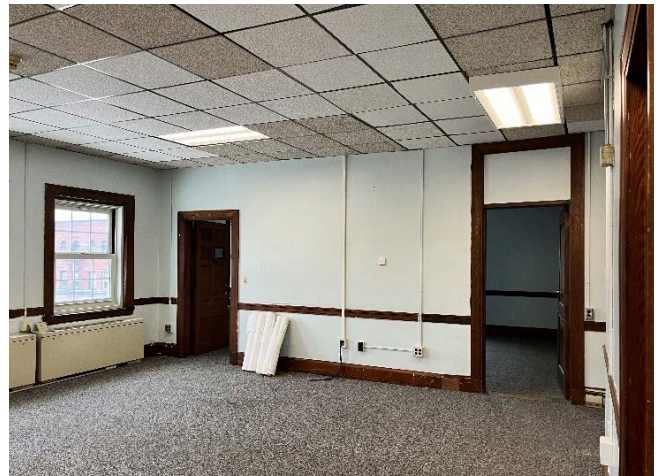
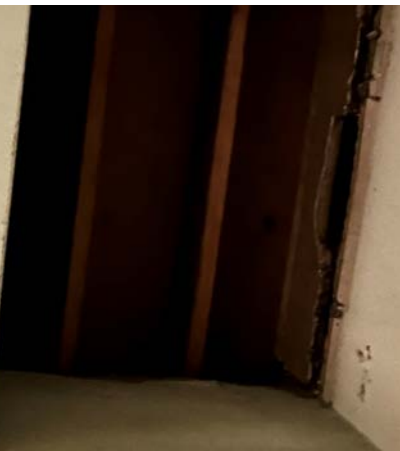
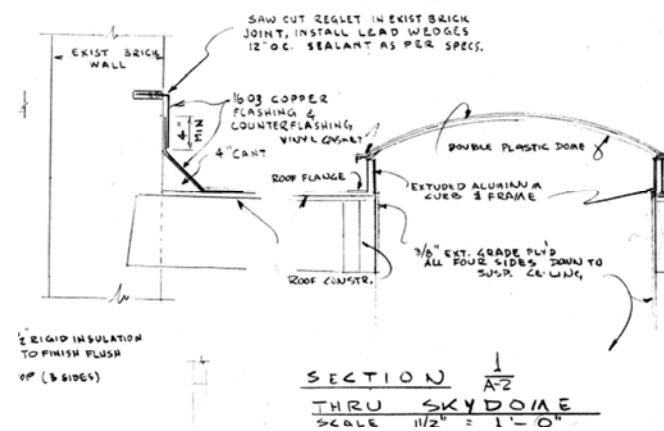
The roof framing was mainly covered with finishes, but there was one location where it could be observed and was found to be wood joists. It is believed that these wood joists are supported on wood or steel beams and masonry bearing walls. (Photos 27-30). This is also how it is diagrammatically shown in the 1972 renovation drawings at the elevator head house (Photo 31). There were no signs of significant deflection or distress of the finishes at the second-floor ceiling that covers the roof framing.
